Causes and Treatment of Hot-rolled Al-Zn Alloy Coated Steel Sheets

Steel exposure is a major defect of hot-rolled Al-Zn alloy coated steel sheets, which are manufactured on the production line of cold-rolled Al-Zn alloy coated steel sheets, using the United States Steel Corp method. This paper experimentally analyzes morphological features of steel exposure, dusts adhered to furnace roller and degreasing cleaning technology, identifies the main causes of steel exposure, and proposes a method to eliminate the defect, providing a solution to insufficient solder.

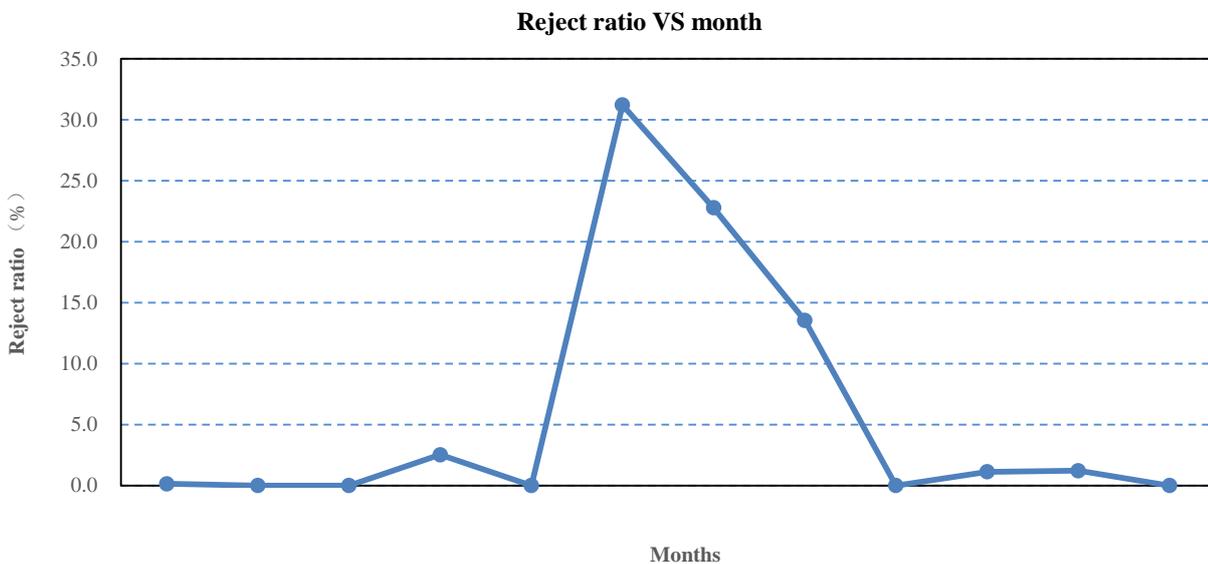
Fig 1: Reject ratio of the finished products

During the trial production of hot-rolled Al-Zn alloy coated steel sheets, many steel exposure/insufficient solder appeared in the early phase. The reject ratio of the finished products once surpassed 30%, as shown in Fig 1. Making it necessary to identify the causes of the defect and find preventive measures[17].

In general, the hot-rolled Al-Zn alloy plating unit should be degreased and washed with desalted water, whose hardness is about 0.1mg/L and conductivity is about 0.1 μ s/cm. To clean the front panel, the conductivity of the cleaning tank must be controlled below 10 μ s/cm. Hence, we stepped up the monitoring of the water quality of the desalted water, keeping it within the range specified in the relevant technological procedures. In this way, the reject ratio induced by steel exposure was effectively controlled (as shown in Fig 1).

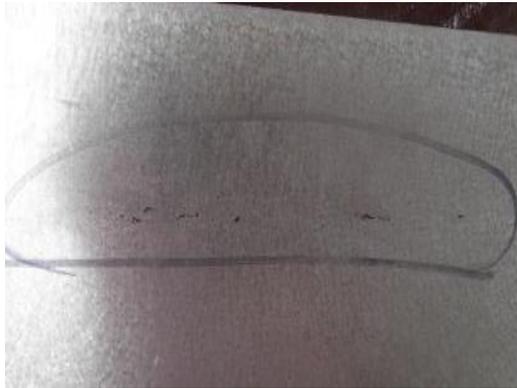
a) Unaided view

Follow-up survey shows that steel exposure spread across the plate surface, with no clear distribution law. Fig 2 shows the macro-morphology of the product. The micromorphology and micro-area composition were analyzed with a JSM-5600LV scanning electron microscope (SEM). The results are displayed in Figure 3 and Table 1. The normal areas are mainly composed of Zn, Al, and O, while the steel exposure areas consist of Fe and O. Apart from Fe, O, Zn, Al, Si, and C, the junction between defects and normal areas contains impurities like Ca, S, Na, Cl, and K. These impurity elements might come from the surface inclusions of base steel, the residual degreasing cleaning liquid (water-based), the furnace dusts adhered to roller and brought to the surface of strip steel, the impurities of plating solution, and sample contamination, to name but a few[18-20].

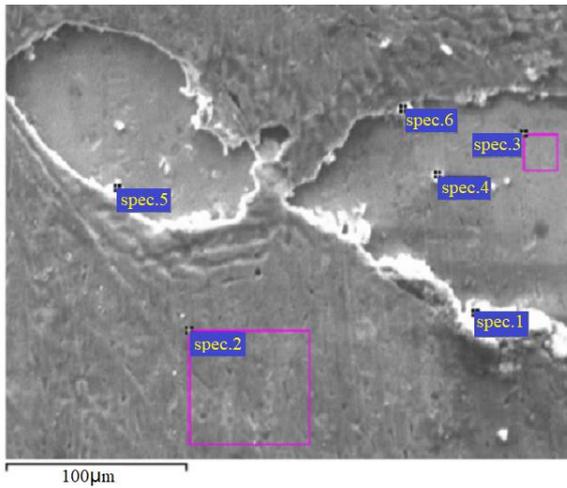
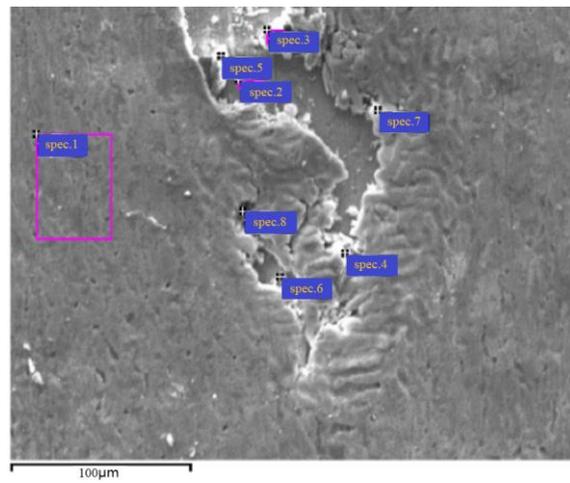
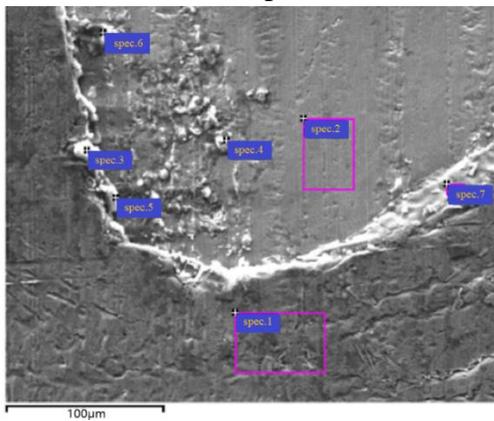
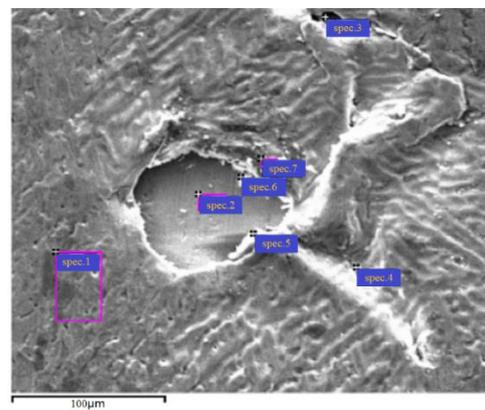
Fig 3: Micro-morphology of the product

The previous studies have shown that the plating solution indeed has a certain number of Ca-containing impurities, as it etches the refractory materials in the zinc pots. However, these impurities will not cause steel exposure, but create convex granules. Besides, the defected sample was cleaned by ultrasonics before being observed. The contaminants were basically removed from the sample. Therefore, the Ca, S, Na, Cl, and K detected on the defected sample could not originate from plating solution impurities or sample contamination.

The previous studies have also demonstrated that the surface inclusions of the base steel could reduce platability, which in turn brings steel exposure, and the resulting defect areas would include elements like Ca, S, Na, Cl, and K. Nevertheless, empirical evidence suggests that the steel exposure induced by inclusions should appear as intermittent dots and lines, accompanied by many convex strips. These defects should have been noticeable before plating. Hence, it is preliminary judged that the inclusions of the base steel are not a major cause of steel exposure.

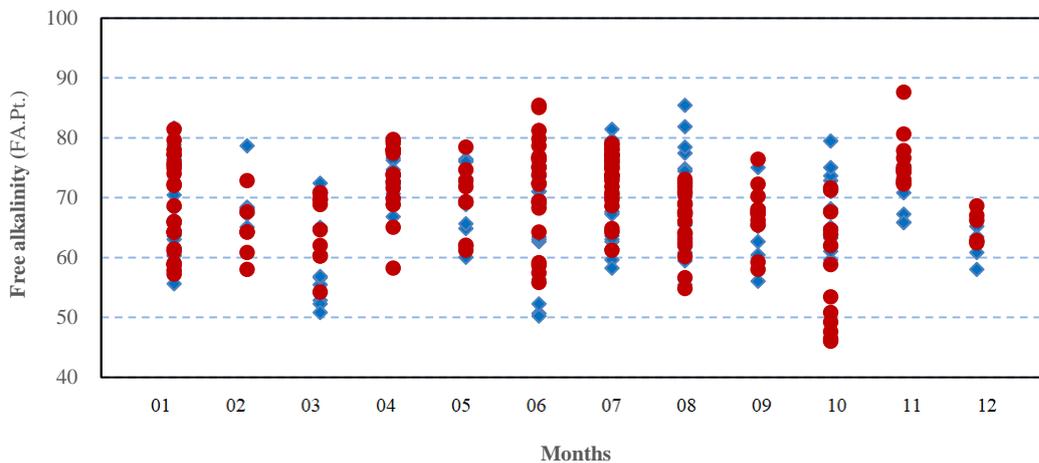
Fig 4: Free alkalinity of degreasing tank

As shown in Fig 4 and 5, the free alkalinity of the degreasing tank remained normal, but the conductivity of the cleaning tank surged up when the reject ratio caused by steel exposure was high (as shown in Fig 1). The upsurging conductivity could be attributed to the high free alkalinity of the degreasing tank, or the entry of alkaline liquor into the cleaning tank due to the insufficiency of rinsing water; the poor quality of cleaning water in the degreasing tank, which contains lots of electrolytes.

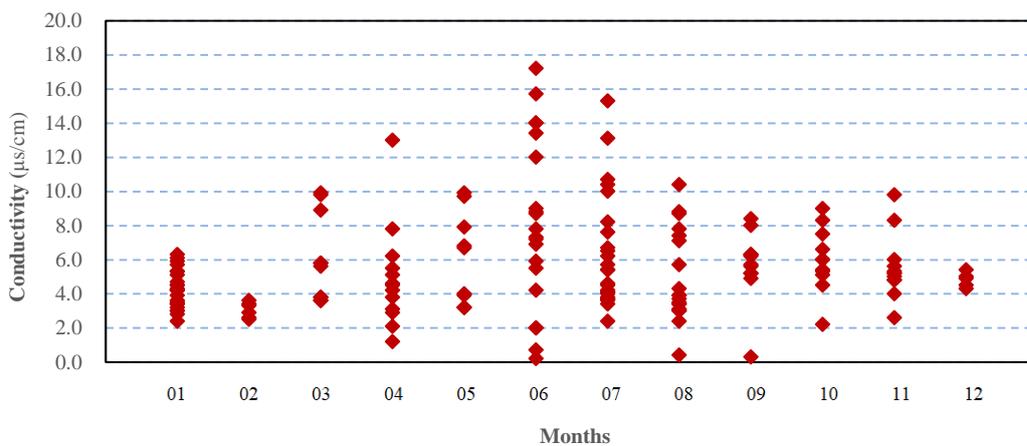
Fig 5: Conductivity of cleaning tank

The survey on degreasing and cleaning technologies shows that: when the reject ratio caused by steel exposure was high, the free alkalinity of the degreasing tank remained normal, but the conductivity of the cleaning tank surged up. Therefore, there is a problem in the quality of the desalted water used for degreasing and cleaning. Since the previous defect feature analysis concludes that the defect areas contain Ca, S, Na, Cl, and K, it can be deduced that the content of calcium ions, sulfate ions, and chloride ions in the rinsing water increases, and some of these ions remain on the surface of the strip steel; the ensuing reduction in platability causes the defect of steel exposure / insufficient solder.
