Analysis of Radiation Protection Detection Results of Some Container Vehicle Inspection System

Abstract:

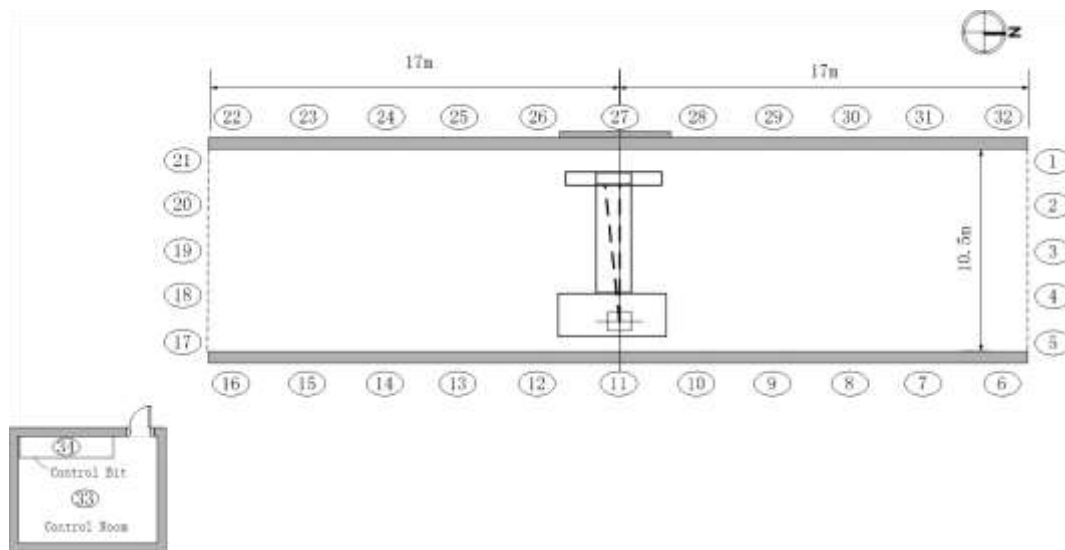
Figure 1 Inspection point layout diagram

During the detection of the radiation level at the boundary of the supervision area of the inspection system, the radiation source was made stand still when the output parameters of the accelerator were adjusted to the maximum state, and the dose equivalent rate around the outer boundary of the supervision area was measured and recorded. See Fig 1 for the schematic diagram of the detection points. No.1 to No.5 are the northern boundary detection points. No.6 to No.16 are the eastern boundary detection points. No.17 to No.21 are the southern boundary detection points, and No.22 to No.32 are the western boundary detection points.
